BEAVER RIVER. HERKIMER COUNTY

STILLWATER RESERVOIR DAM

PHASE I INSPECTION REPORT NATIONAL DAM SAFETY PROGRAM

NY 00316

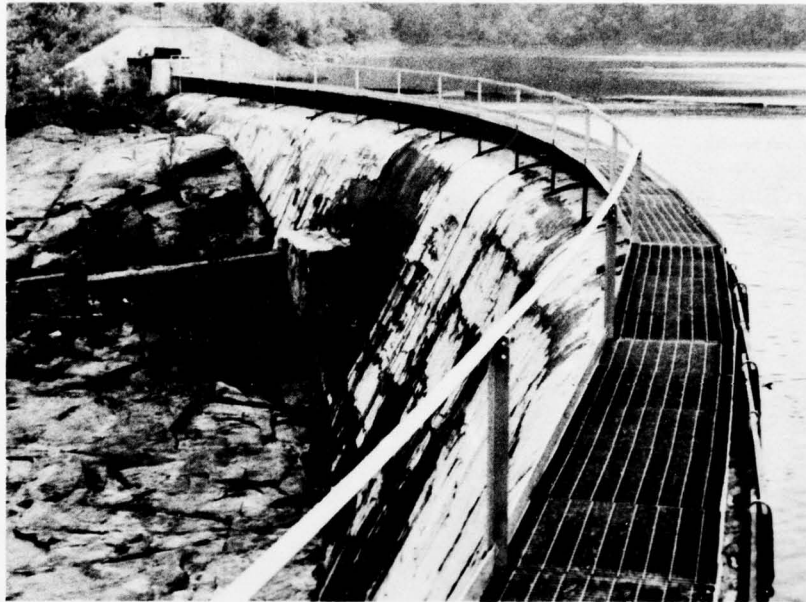
e. Seismic Stability - According to the Geologic Map of New York (Adirondack Sheet) dated 1970, Stillwater Reservoir Dam is founded on granitic-gneiss type rock. Massive rock outcrops were observed in both abutments of the concrete gravity dam and the south dam. The rock outcrops appear to be coarse grained in texture and display random fracturing patterns.

VIEW OF CONCRETE SPILLWAY AND ROCK OUTCROP

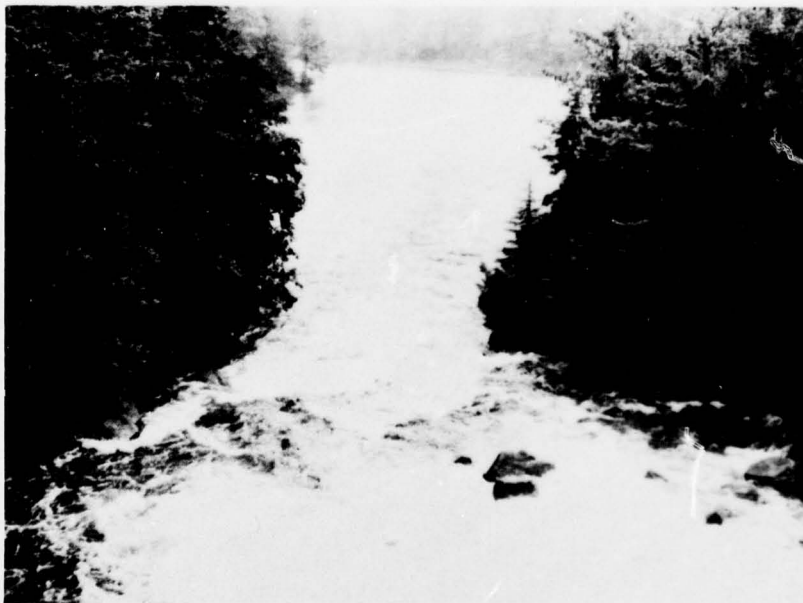
The channel below the gatehouse and spillway is formed in natural massive rock outcrops. No erosion of the rock was observed.

DOWNSTREAM CHANNEL

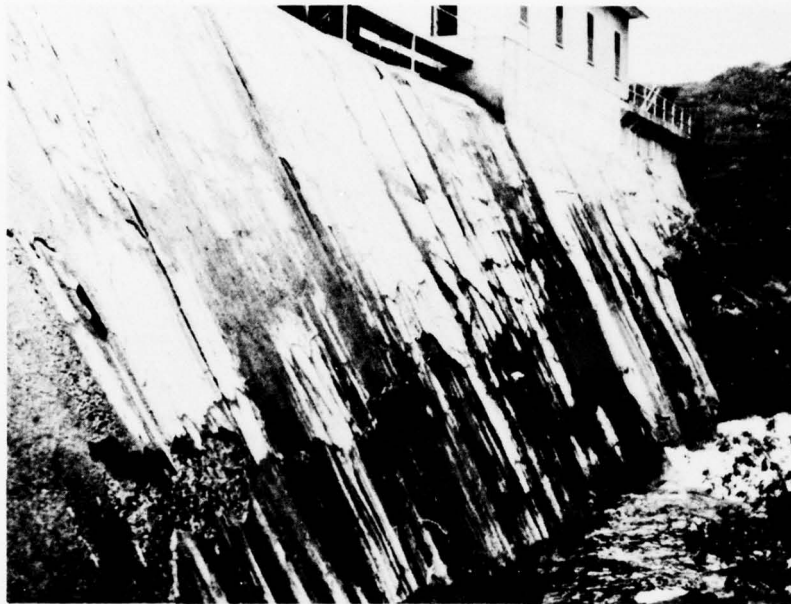
The downstream face of the spillway has also been surfaced with a protective material. A much more significant deterioration of the material than observed on the non-overflow section was evident. In areas where the material had dislodged from the structure, spalled concrete was again noted. No seepage was observed in the toe area of the gravity section.

The concrete surface protection has cracked and spalled in several places on the downstream face of the gravity structure. However, this condition does not appear to adversely affect the stability of the structure.

DOWNSTREAM SLOPE OF SPILLWAY

3. Remove and replace the deteriorated concrete surface protection material as required.

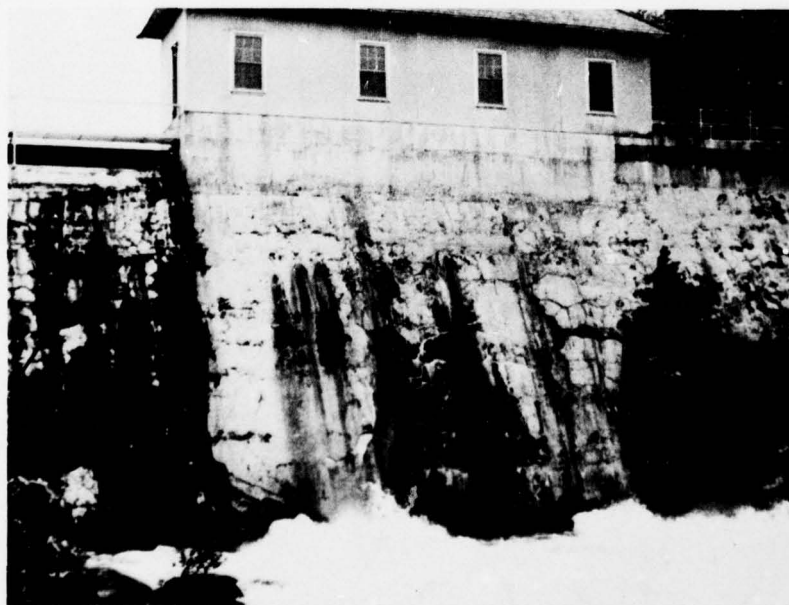
A steel stoplog assembly which can be placed in any of the four discharge openings is stored in the gatehouse. All equipment appears to be in good condition. According to the gatehouse superintendent, all the hoists are operable.

DOWNSTREAM FACE OF GATE HOUSE

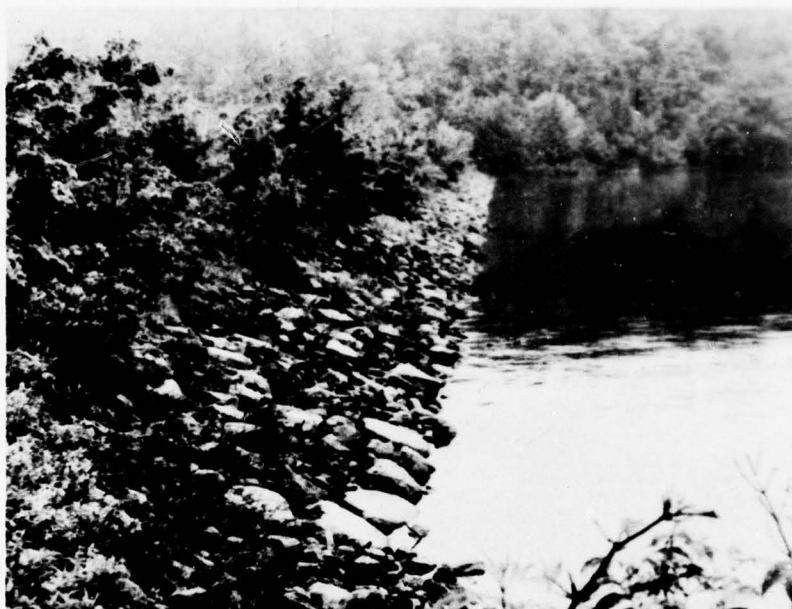
The upstream slope is protected with a blanket of dumped granitic type riprap, ranging in nominal sizes from 4 inches to 24 inches. A significant growth of small sapling trees and brush are located along the crest and upstream slope. No significant settlement or erosion were observed along crest. Two capped galvanized metal pipes about two inches in diameter were located in the center of the crest. Operating personnel indicated no knowledge of these pipes or their function.

NORTH DAM (UPSTREAM SLOPE) LOOKING NORTH

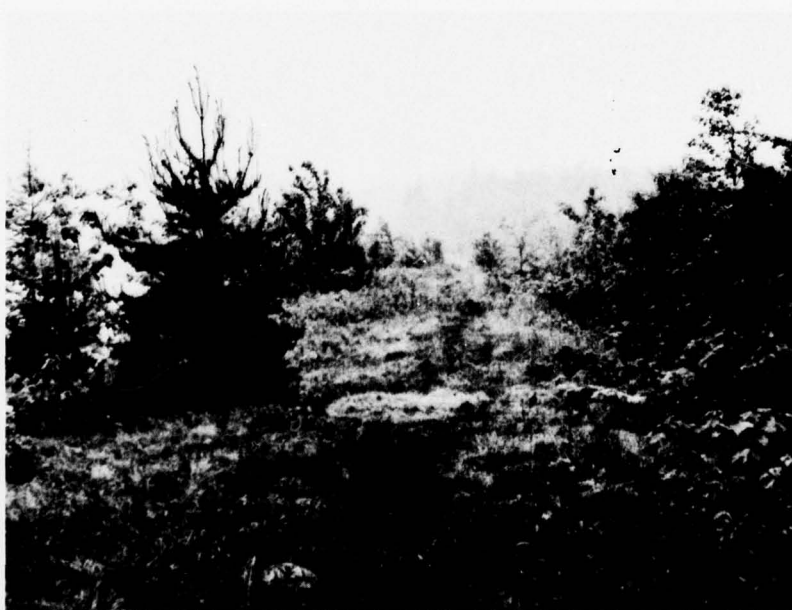
CREST OF NORTH DAM LOOKING SOUTH

VISUAL EXAMINATION	OBSERVATIONS	REMARKS OR RECOMMENDATIONS
MONUMENTATION/SURVEYS	None Noted.	
OBSERVATION WELLS	Capped pipes (2), in the vertical position, were located along the crest of the north dam. Their function was unknown to operating personnel.	
WEIRS A-13	None Noted.	
PIEZOMETERS	None Noted.	
OTHER	N/A

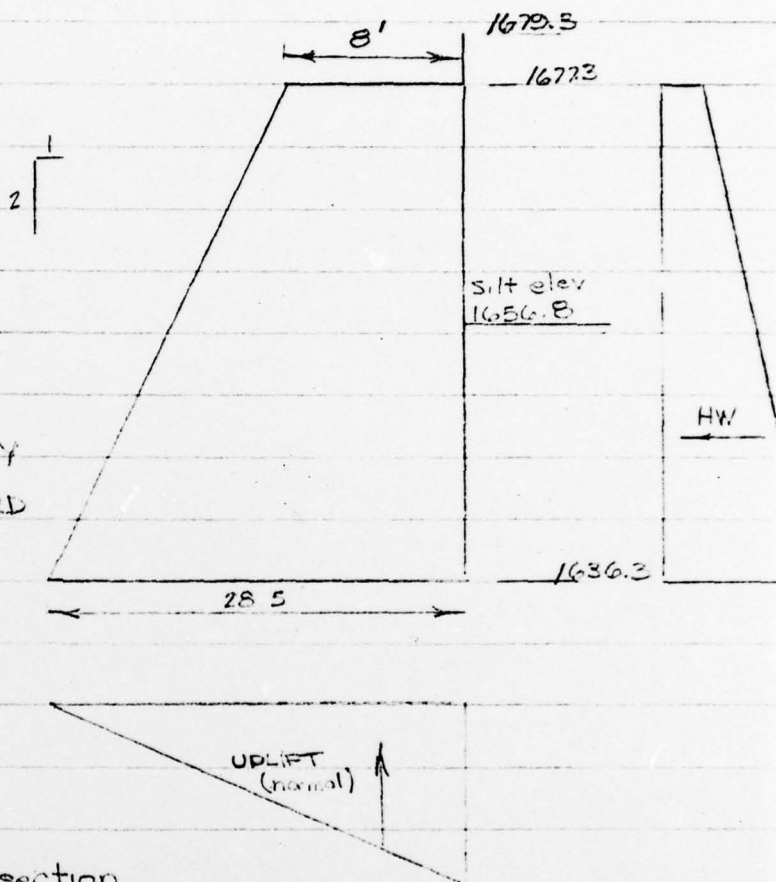
SPILLWAY SECTION

A review of the results indicates that the resultant is located a significant distance outside of the middle third of the base for the normal and PMF loading conditions; the resultant of the seismic loading falls within the limits of the base width.

A review of the stability analysis indicates that the spillway is structurally unstable relative to resultant location for normal and PMF loading conditions. However, in the analyses, the spillway was evaluated as a simple gravity structure; no consideration was given to the curvature of the spillway which could significantly improve the stability of the structure.

LOADING CONDITION	SF - AGITATION	SF - SLIDING	BEARING PRESSURES
NORMAL POOL	1.2	7.1	46.7 psi - 14.3 psi (Tension)
EARTHQUAKE	1.0	5.6	60.9 psi - 28.5 psi (Tension)
PMF	1.0	6.0	59.6 psi - 29.2 psi (Tension)
